Infrared Thermography Report

RE: Infrared Thermography Survey

For – Company - Sample
Site - XXXX

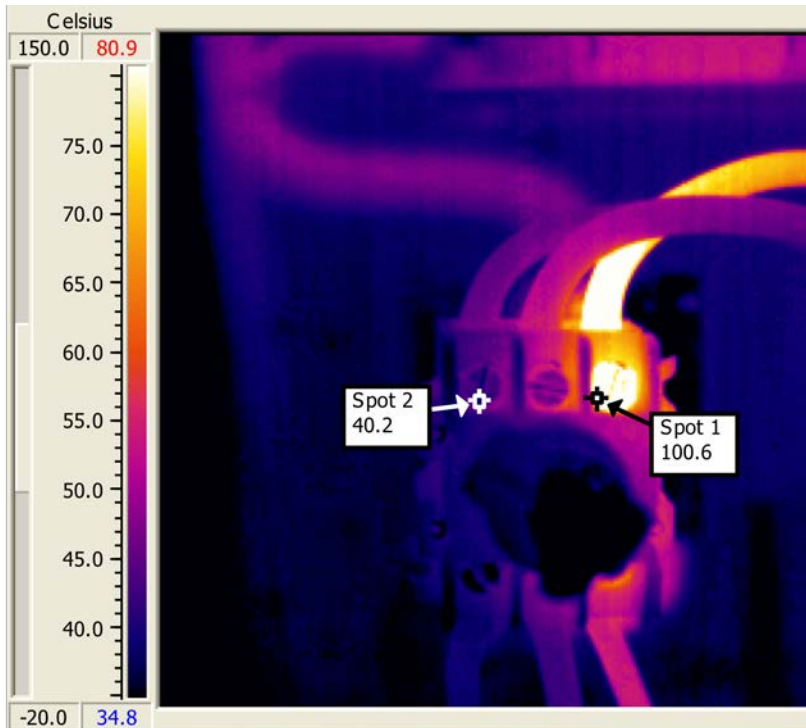
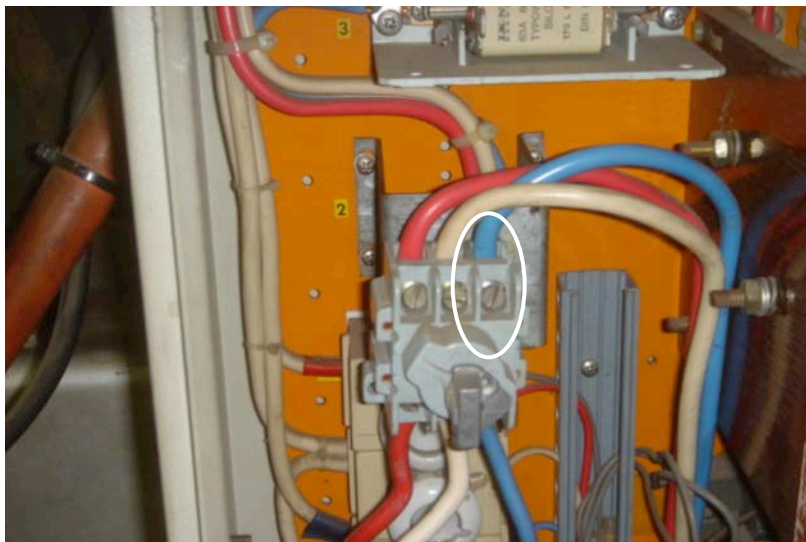
Fault Location	
Cabinet ID	Line 7 Extruder
Point ID	RHS-2
Component ID	Main Isolator
Fault Location	Blue Phase

Fault Description
Main Isolator Connection end hot Loose or improper connection
23-May-06 Adam Walker

Priority – SERIOUS
Repair within 1-2 weeks. Replace component; inspect for damage to adjacent component.

Recorded Temperatures	
Fault	100.6 C
Reference	40.2 C
Ambient	21.0 C
Delta Temp.	60.4 C

Comments
This fault was present last survey and is now a lot hotter.

Recommended Actions
Rework the connection ensuring it is clean and tight.

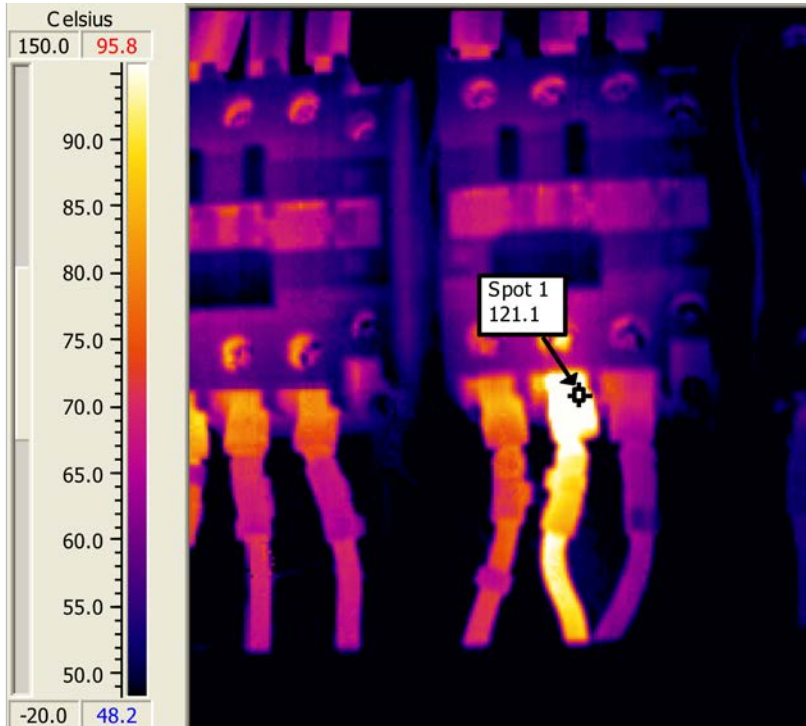
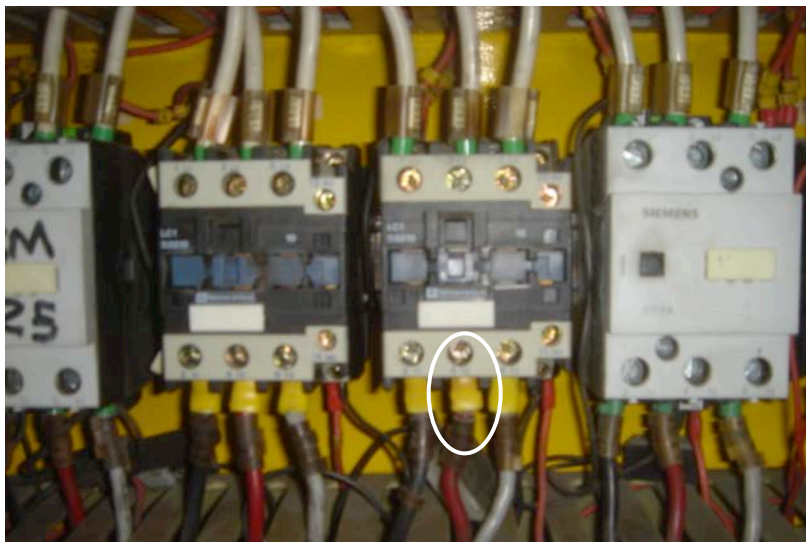
Cabinet ID Line 1
Point ID Curing Oven
Component ID Contactor K194
Fault Location T2

Contactors
Connection end hot
Loose or improper connection

Priority – **SERIOUS**

Fault 121.1 C
Reference 58.0 C
Ambient 21.0 C
Delta Temp. 63.1 C

Rework the connection.
Re-crimp new lug to wire.

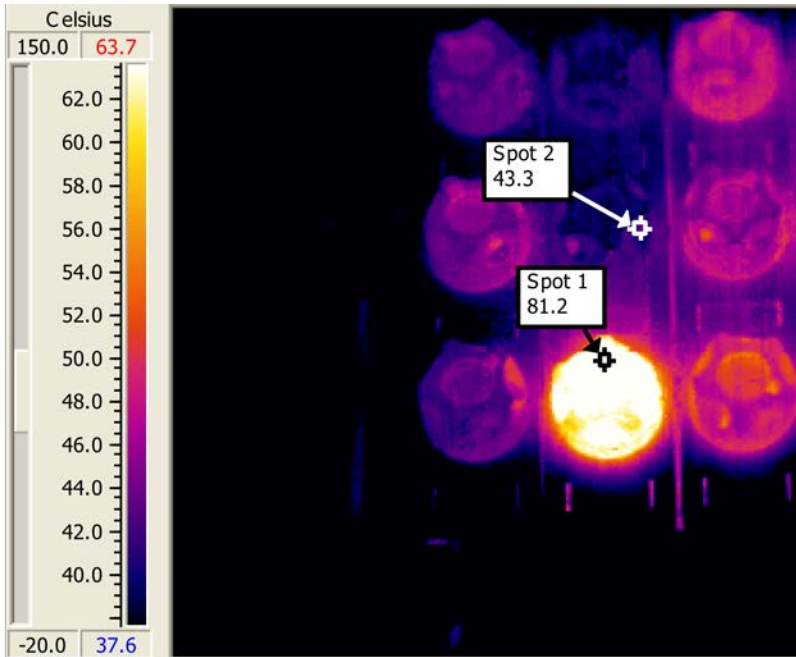
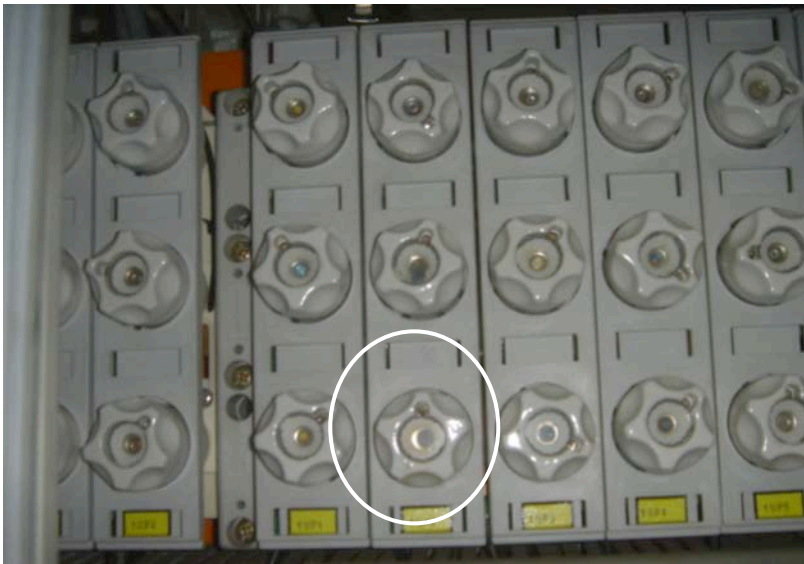
Fault Location	
Cabinet ID	Klopper No. 1
Point Description	Control Panel
Component ID	Fuse 19F2
Fault Location	Bottom phase

Fault Description
Fuse Fuse body hot Loose connection or loose fuse in holder
30-May-06 Adam Walker

Priority – INTERMEDIATE
Repair within 2-4 weeks. Inspect for physical damage and watch for load changes. There is a chance of component damage.

Recorded Temperatures	
Fault	81.2 C
Reference	43.3 C
Ambient	21.0 C
Delta Temp.	37.9 C

Recommended Actions
Rework the connection. Ensure fuse holder is tight.
